### 3. Maunders Road Bridge – CFRP plates bonded to cast iron

Maunders Road Bridge consists of 6 cast iron girders with brick jack arches carrying a minor road over a disused railway line. The bridge is owned by Network Rail, and although the line is currently disused, there are aspirations to re-open the line and the structure needed to be strengthened to meet 40 tonne assessment load while removing existing props.

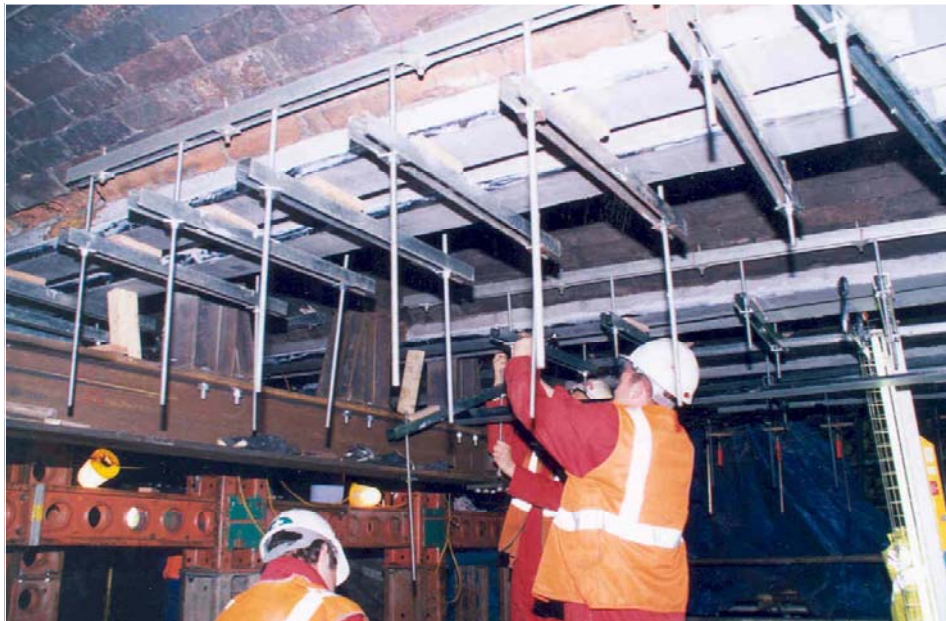
Installation was completed strictly in accordance with the method statement. After the surface preparation was inspected, a thin layer of epoxy adhesive was applied to the beam by trowel, ensuring full wetting of the surface and that all local pitting was filled. A peaked layer of adhesive was applied to the laminates, thicker in the middle than at the edges, so that as the laminates were pressed into place air would be expelled and not trapped within the bond line.

A temporary supports scheme had been developed so that the laminates were lifted into place and forced into the adhesive in a controlled manner. The supports remained in place as clamps, supplemented by additional clamps, until the adhesive had cured. Combining the lifting, positioning, and clamping arrangements to use the same system ensured that there was no possibility of support to the laminates being relaxed as one system was changed over to another. This ensures that air is not drawn into the bond line after excess adhesive has been expelled.

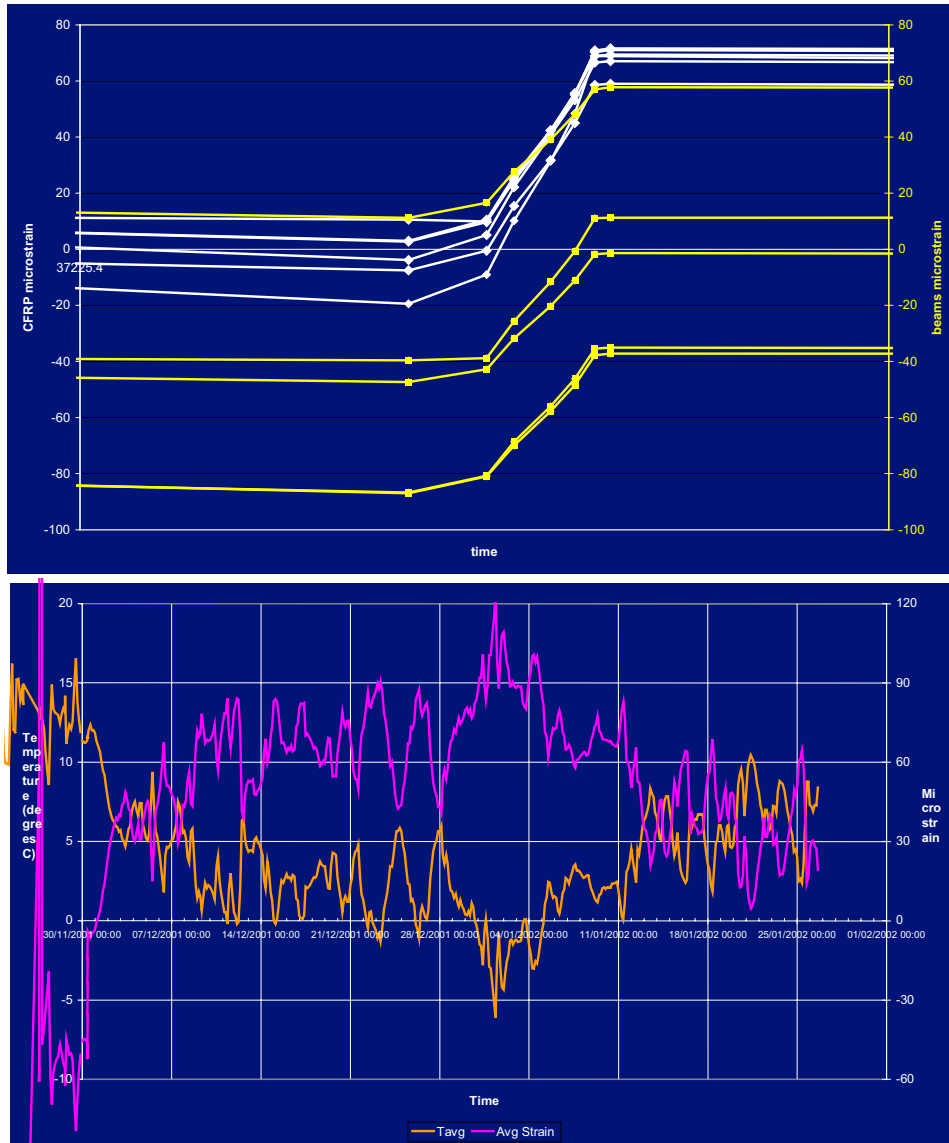
A data logger was installed before works commenced, and was running throughout prop preload, laminate installation and during the removal of the props. The logger recorded data from a strain gauge on every beam, and on at least one laminate of each beam. It also recorded the surface temperature on two of the beams. This level of monitoring would not be considered necessary for a typical unstressed strengthening scheme, but was considered prudent because of the innovative nature of the project at the time it was undertaken.

Following completion of the works the information from this was compared with theoretical predictions and also cross-referenced with the contractor's records of environmental conditions. The correlations were very good. For example, the measured stiffness of the strengthened beams was approximately 2.5 times that of the unstrengthened beams, and the theoretical prediction was between 2.4 and 3.2 times (within the likely range of properties for the existing materials). The measured strain profile indicated the neutral axis of the strengthened beam at 90mm above the soffit, and the theoretical range was 112 to 92mm.

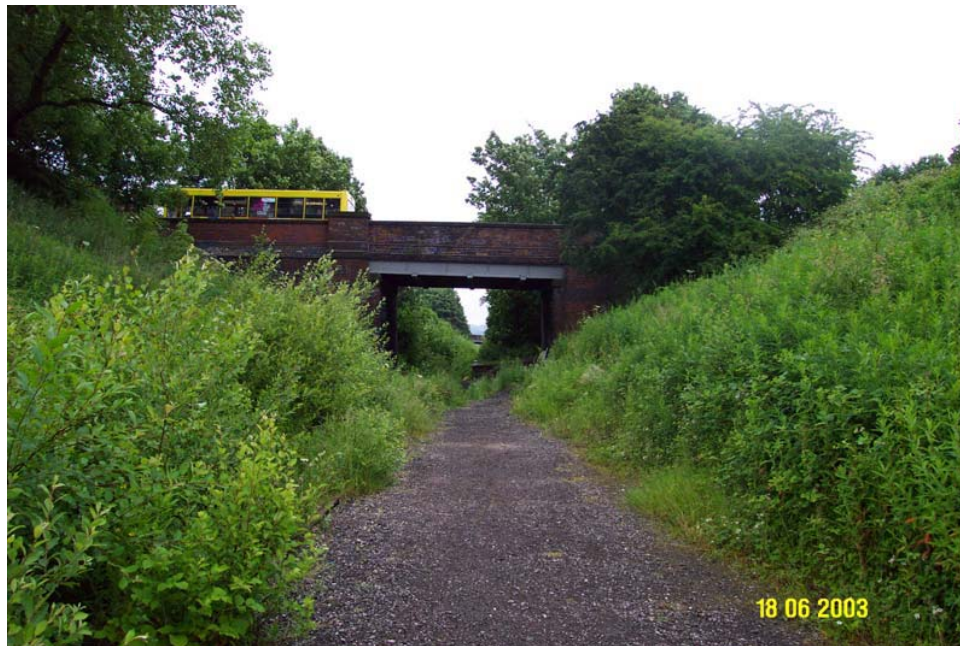
Since installation, the bridge has been subject to periodic visual inspection, and one detailed inspection during which the laminates were tap-tested to confirm that no delamination had occurred. All such inspection and testing has reached satisfactory conclusions.
